Monitoring Data RecordProject Title: I-540 Northern Wake Expressway (R-2000AB) COE Action ID: 200021863Stream Name: UT to Kit Creek DWQ Number: 030918City, County and other Location Information: Wake County, Site 6 (Sta.10+41 to 12+76 YRPA-)Date Construction Completed: March 2005 Monitoring Year: (5) of 5Ecoregion: _____ 8 digit HUC unit 03030002

UT Kit Creek

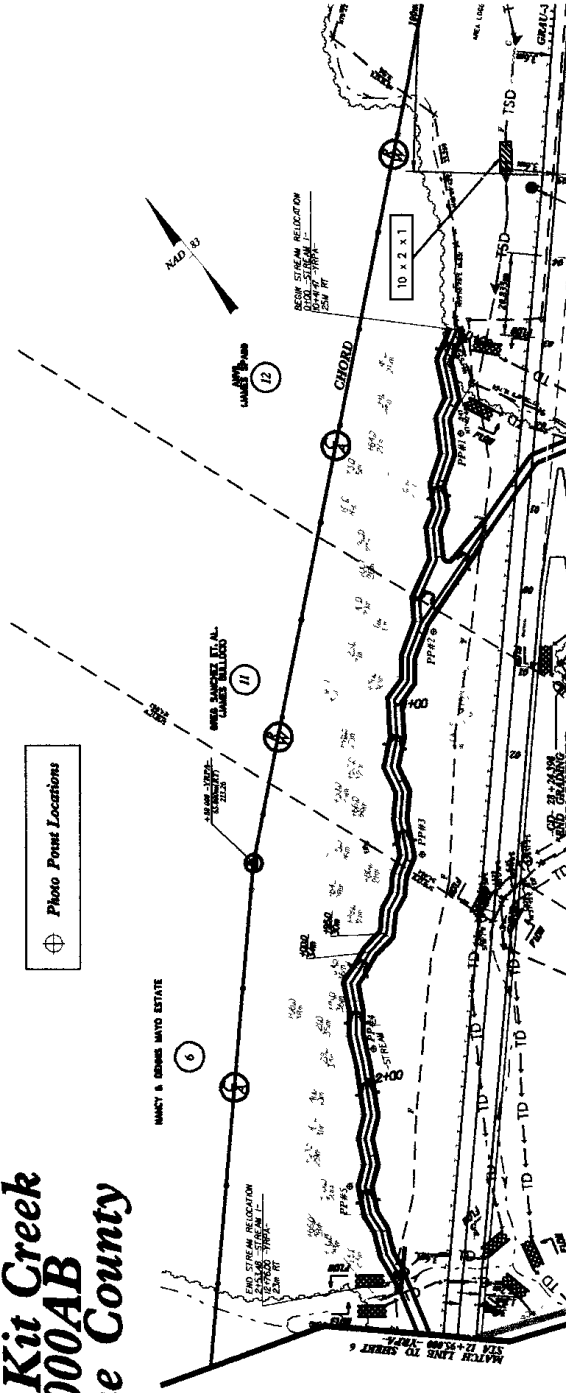
Date 7/29/10	Station Number 0+90 –Stream 1- (Additional Photo)	Station Number 2+00 –Stream 1-	Station Number	Station Number	Station Number
Structure Type		Crossvane			
Is water piping through or around structure?		Water piping under crossvane			
Head cut or down cut present?					
Bank or scour erosion present?					
Other problems noted?	Beaver dam noted

Photo of Beaver Dam at Sta. 0+90 –Stream 1-
